ATS PROPERTY INSPECTIONS

CONFIDENTIAL INSPECTION REPORT

123 Sample Drive, Chattanooga, TN 37421

5/8/2005 9:00 am to 2:10 pm

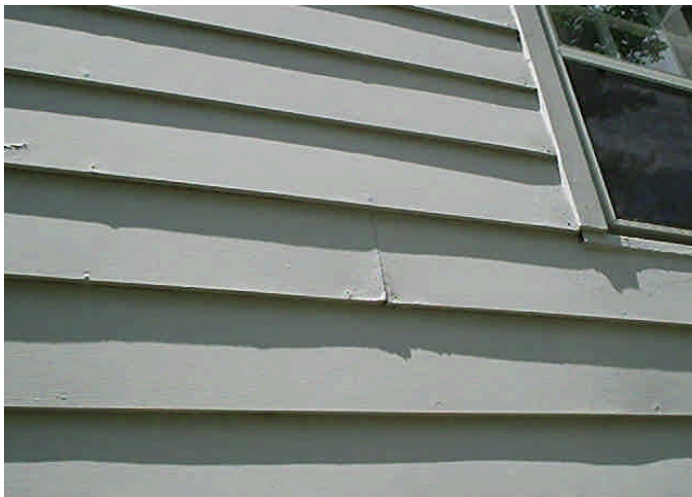
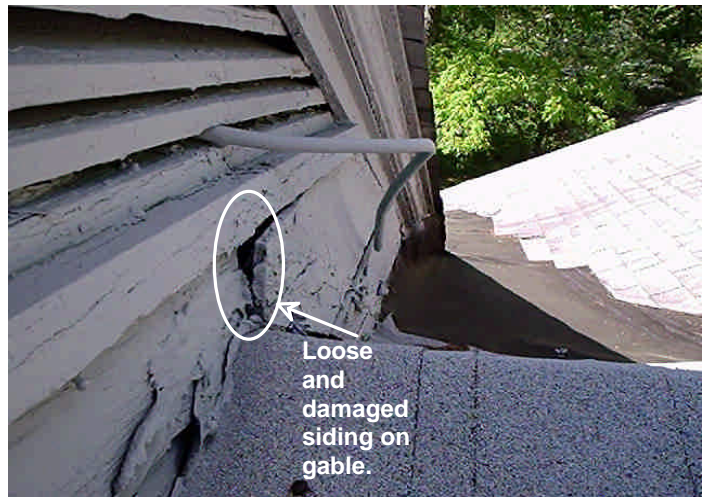
- +There is siding damage noted that will require repair.-Masonite type de-laminated-overdriven nails-apartment side-rear offset left side of house-several areas of wood may need replacement-loose on gable end at upper roof area-Attention

- + Paint/finish is deteriorated at the walls - Attention.
- + The siding nailing appears improper, evaluate further for required nailing pattern - overdriven nails in fibrous siding-Review.
- + The structure appears to be clad with siding that may be considered to be a manufacturers defect - fibrous on house-Review.

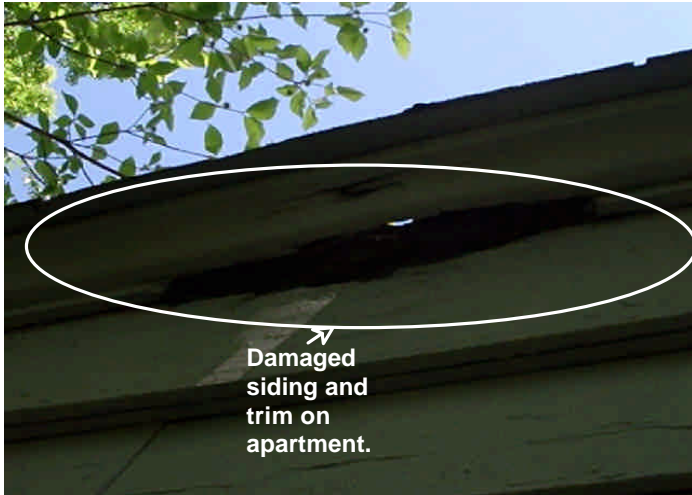
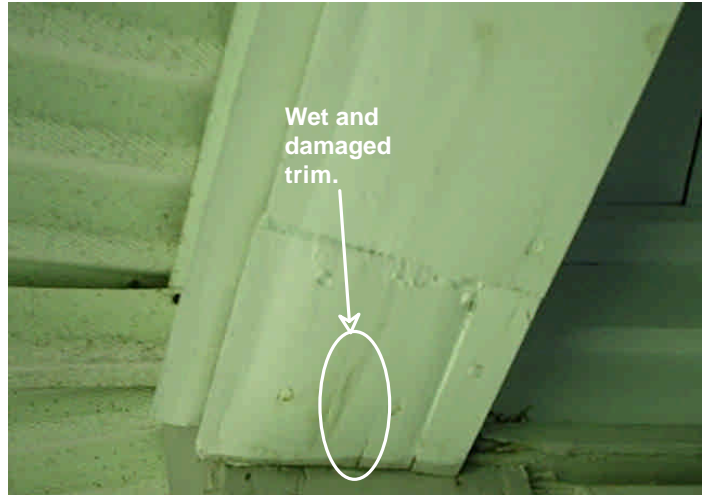
- + Damaged trim was observed at the property - apartment side-rear patio side header cover has water leaking into it--Attention.

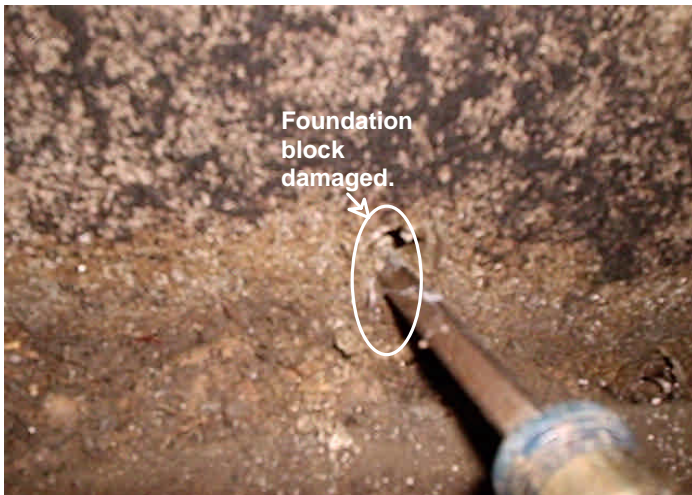
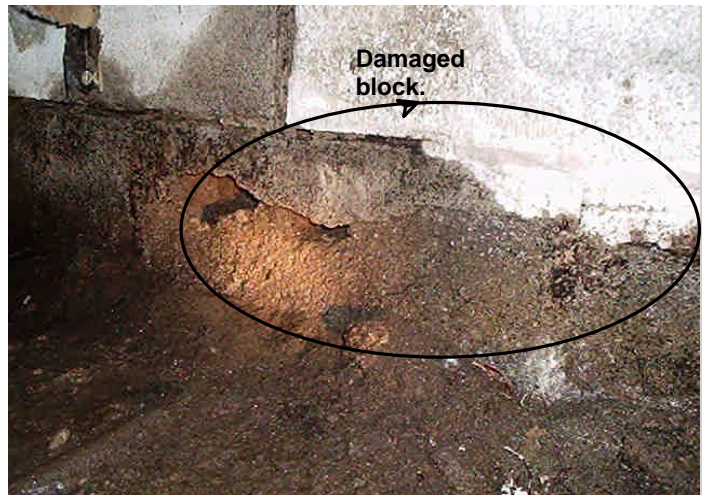
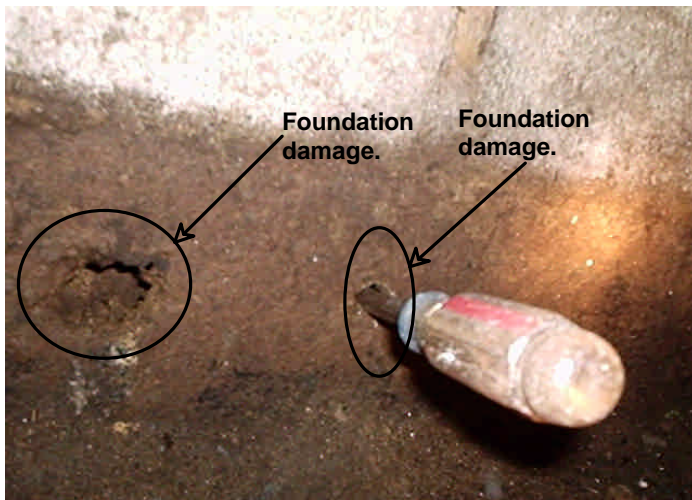
- +The foundation blocks are deteriorating due to the constant wetting and drying process caused by water penetration into the crawl area.-apartment-structural damage to foundation-Attention.

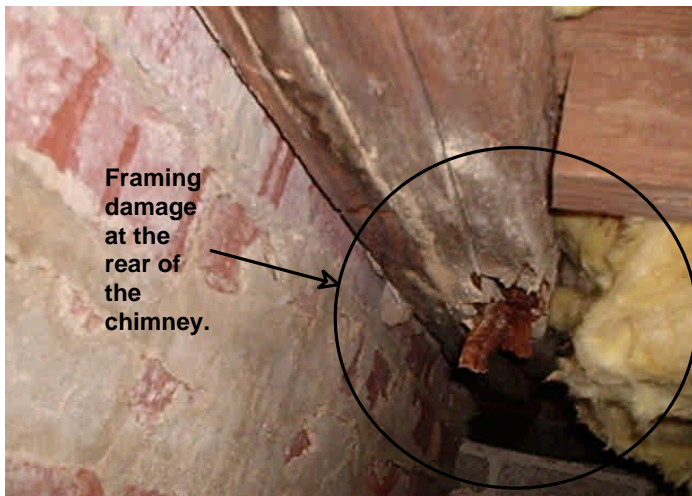
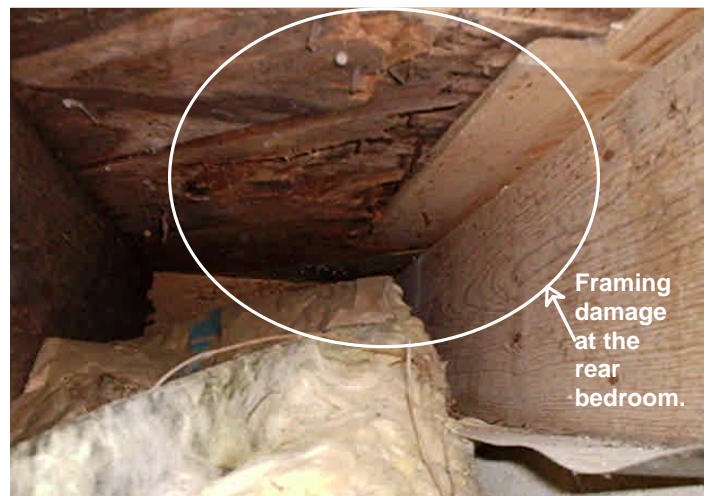
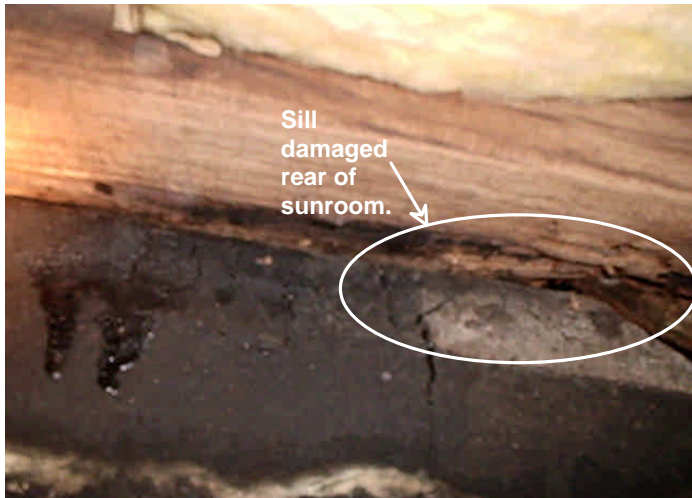
- + Damaged/cut/sagging framing was observed - rear wall of sunroom on house is damaged at sill, ledger and band joist-left side wall of left bedroom at rear of side wall may be damaged as it has a temporary support under it. There is damaged framing on the floor at the rear of the left side bedroom.-there is damaged framing at the old fireplace at the bedroom side-cut and damaged framing below the hallway bathroom-Attention.

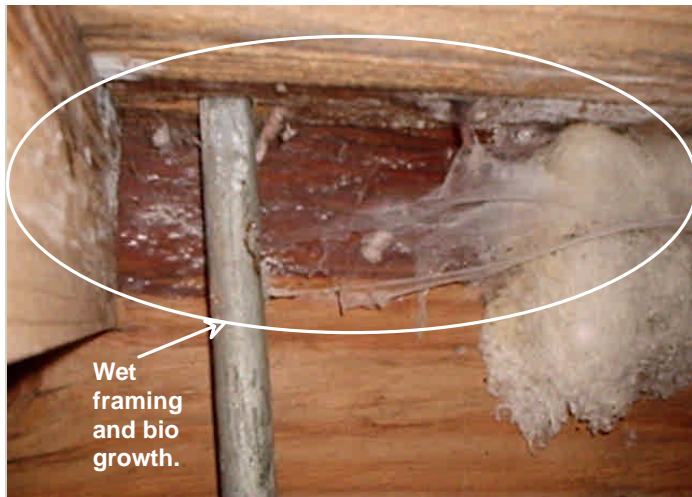
- +There was wet and stained framing noted.-rear wall of apartment bathroom/kitchen area-Attention.

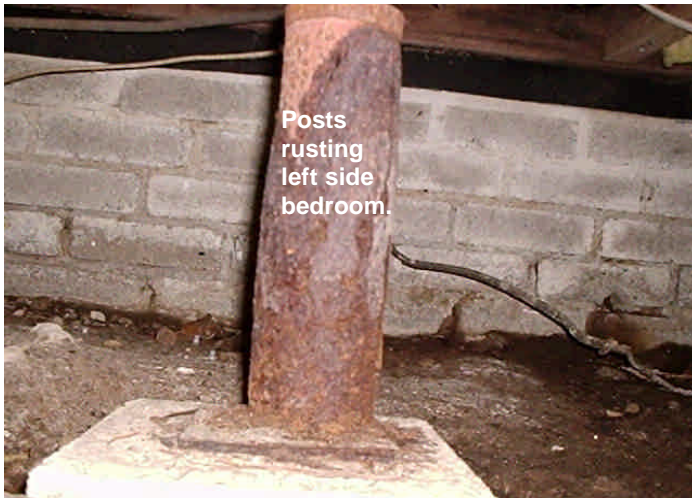
- +There are metal posts supporting the framing which are rusting at the base.-under the left side bedroom-Review

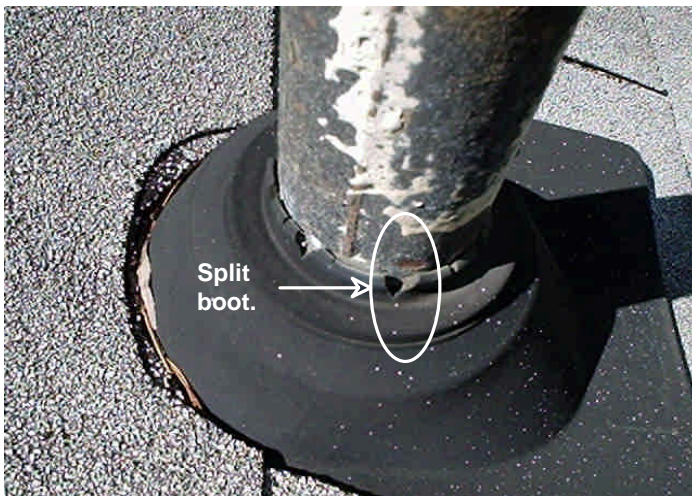
- +The vent stack boots are split and need replacing.-boot split master bathroom-tar on boot at the apartment-split boot hallway bathroom-check all-Attention.

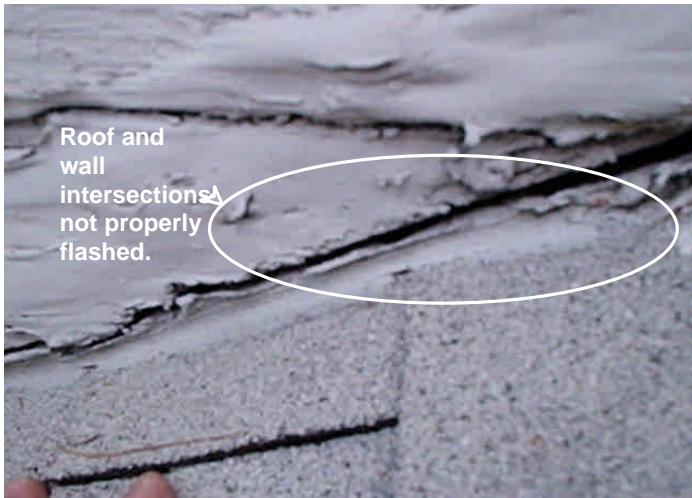
- +Step flashing not visible at the roof and wall intersections.-house-garage-Attention.

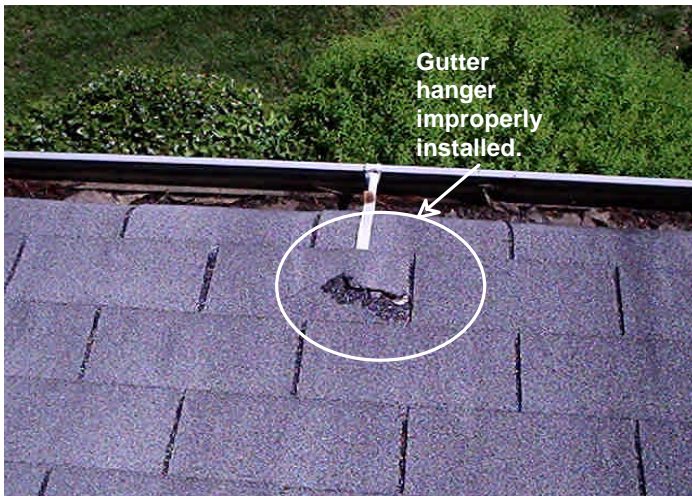
- + The roof drainage system should be cleaned - Attention.
- + There are partial gutters on the structure (which are helpful in protecting the foundation), installation should be considered - Review.
- +The gutter hangers are incorrectly installed.-Attention.

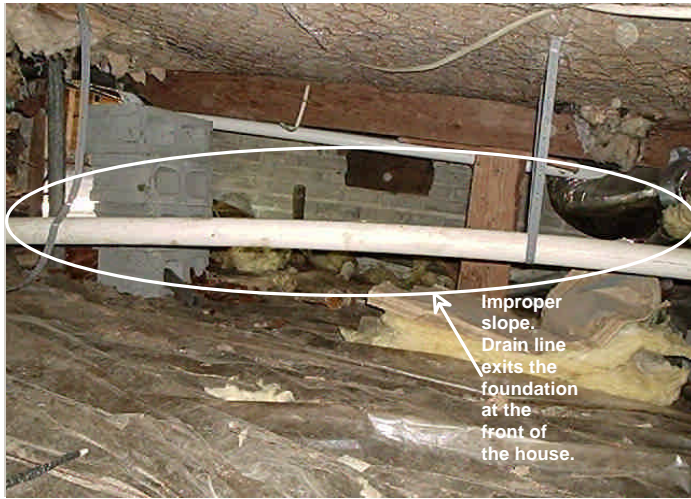
- + Given the age of this residence, it is possible that the drainpipes are old. Older piping is susceptible to decay, therefore, it would be prudent to ask the sellers if they have replaced the piping, ever had blockages in the main drainpipe, and/or have the line video-scanned - Review.
- +There is visible corrosion on the drain/vent piping.-apartment-Attention
- +The drain lines did not slope for proper drainage.-kitchen sink drain-Attention.

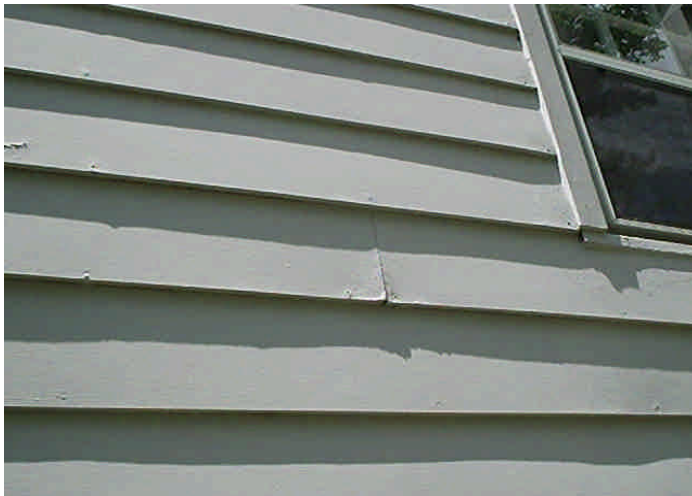
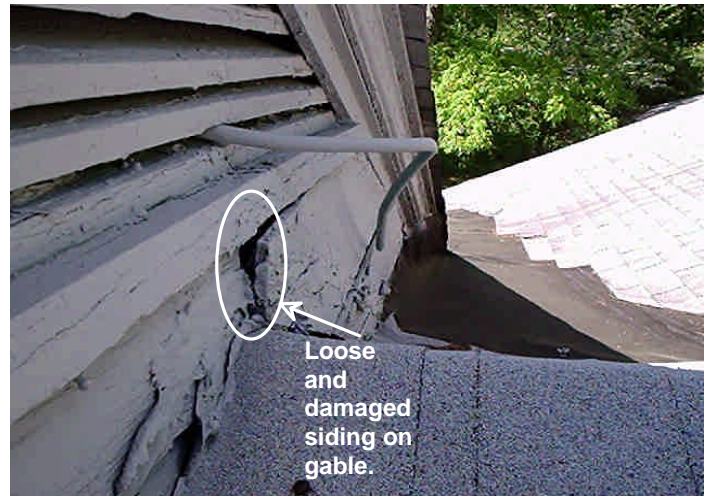
+There is siding damage noted that will require repair.-Masonite type de-laminated-overdriven nails-apartment side-rear offset left side of house-several areas of wood may need replacement-loose on gable end at upper roof area-Attention

- + Paint/finish is deteriorated at the walls - Attention.
- + The siding nailing appears improper, evaluate further for required nailing pattern - overdriven nails in fibrous siding-Review.
- + The structure appears to be clad with siding that may be considered to be a manufacturers defect - fibrous on house-Review.

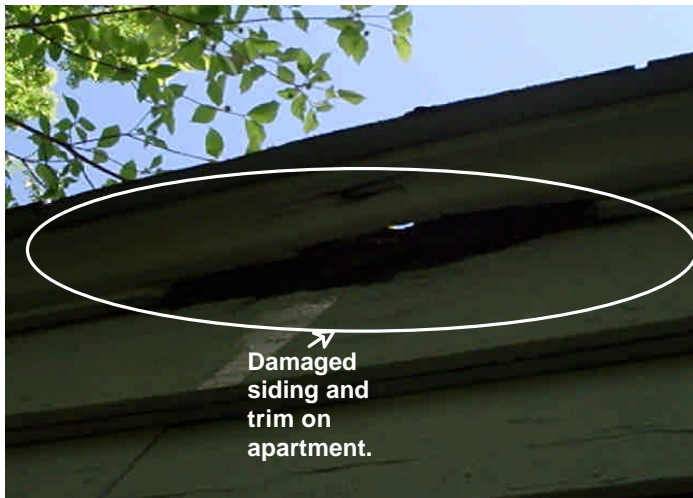
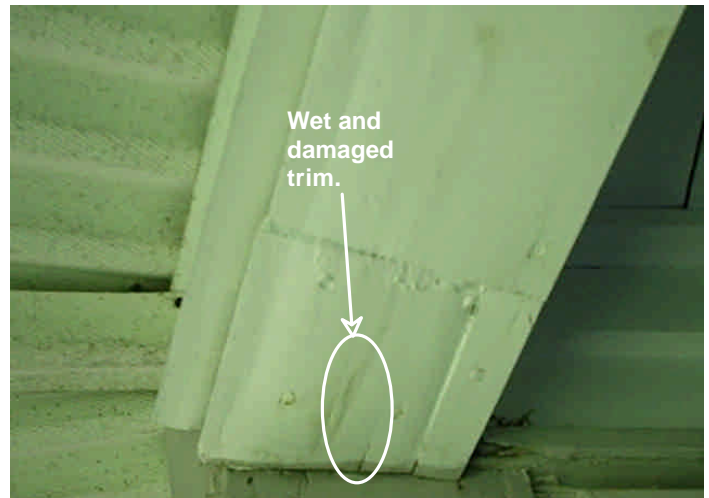
+ Damaged trim was observed at the property - apartment side-rear patio side header cover has water leaking into it--Attention.

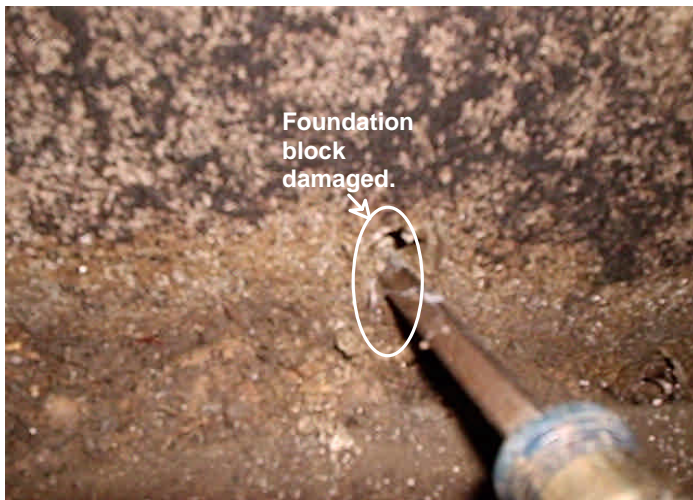
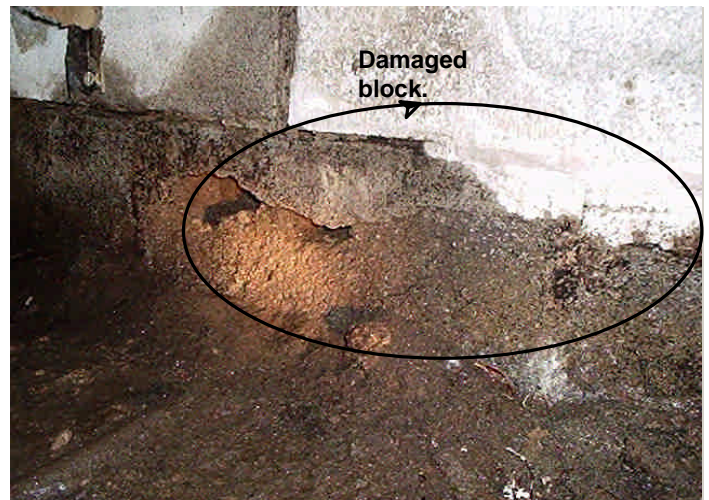
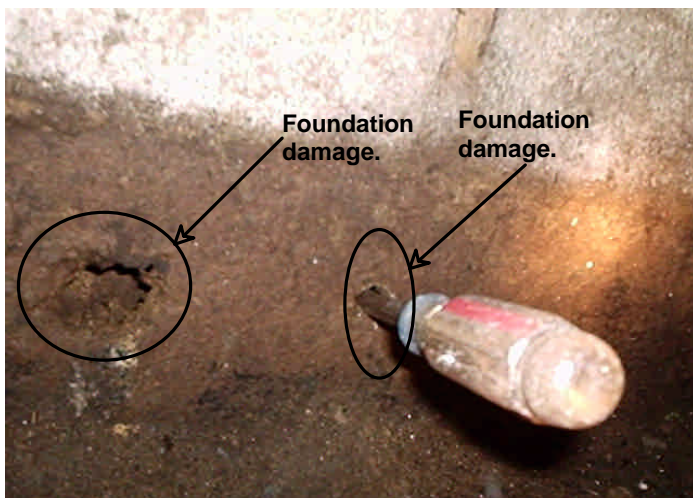
+ The foundation blocks are deteriorating due to the constant wetting and drying process caused by water penetration into the crawl area.-apartment-structural damage to foundation-Attention.

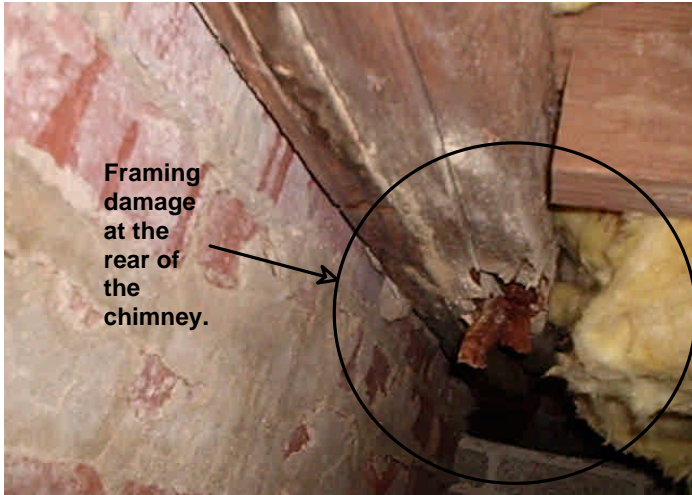
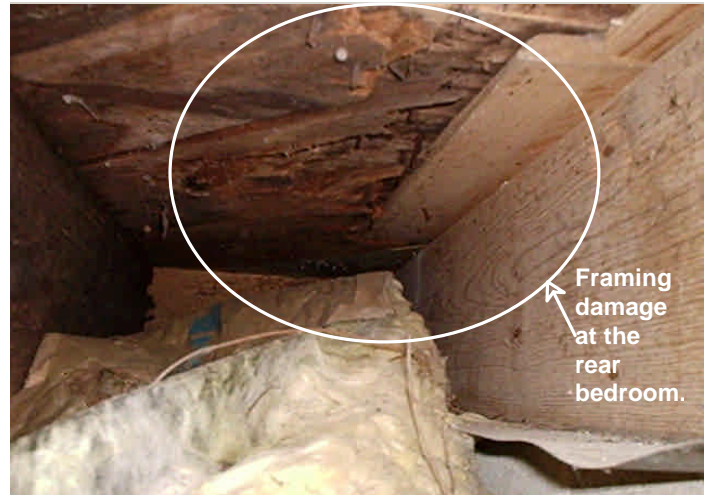
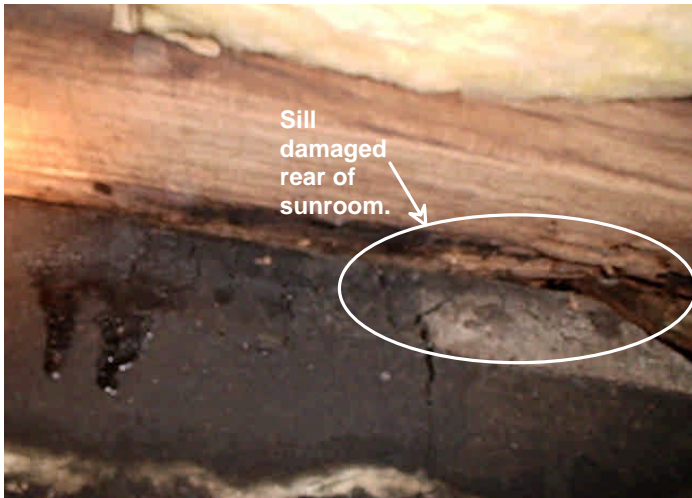
- + Damaged/cut/sagging framing was observed - rear wall of sunroom on house is damaged at sill, ledger and band joist-left side wall of left bedroom at rear of side wall may be damaged as it has a temporary support under it. There is damaged framing on the floor at the rear of the left side bedroom.-there is damaged framing

at the old fireplace at the bedroom side-cut and damaged framing below the hallway bathroom-Attention.

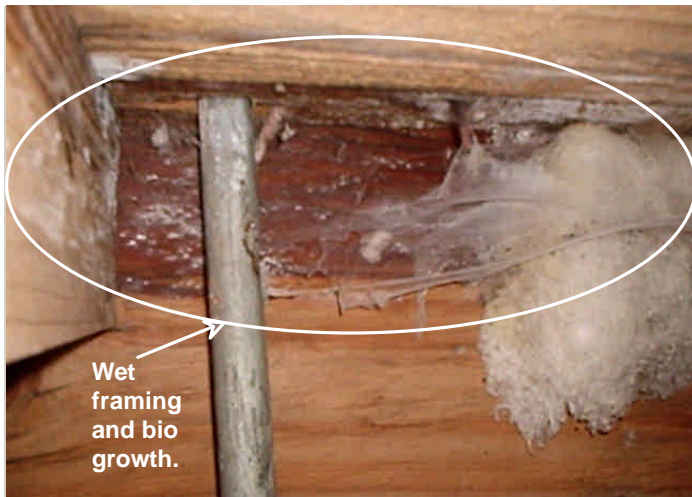
+There was wet and stained framing noted.-rear wall of apartment bathroom/kitchen area-Attention.

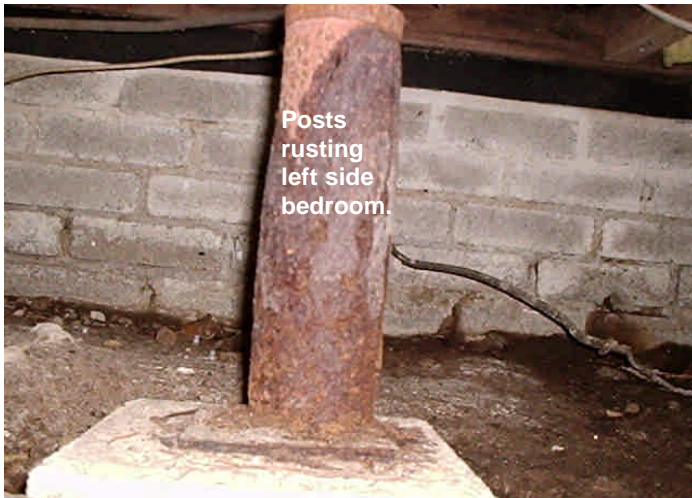
+There are metal posts supporting the framing which are rusting at the base.-under the left side bedroom-Review

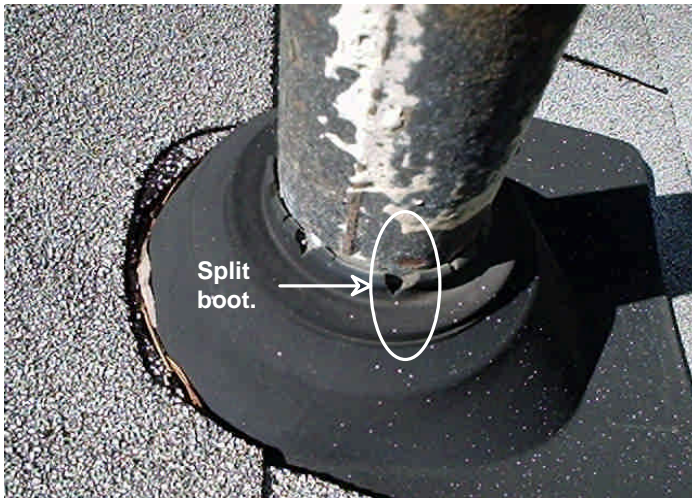
- +The vent stack boots are split and need replacing.-boot split master bathroom-tar on boot at the apartment-split boot hallway bathroom-check all-Attention.

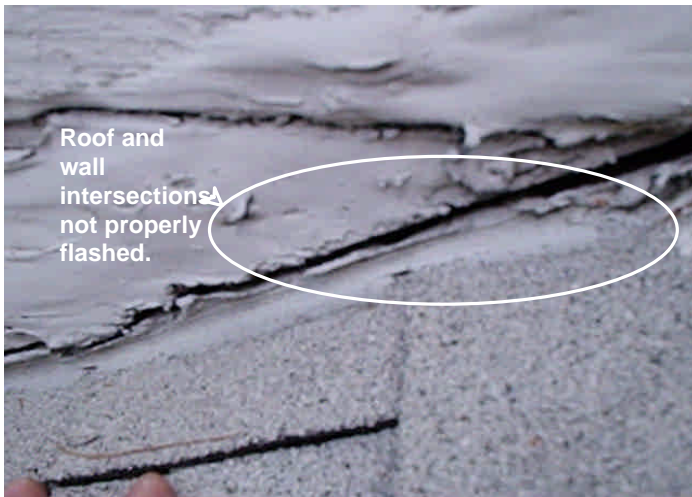
+Step flashing not visible at the roof and wall intersections.-house-garage-Attention.

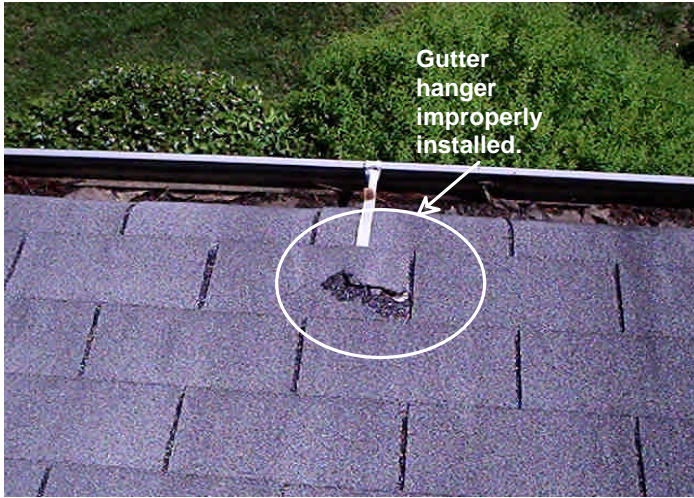
- + The roof drainage system should be cleaned - Attention.
- + There are partial gutters on the structure (which are helpful in protecting the foundation), installation should be considered - Review.
- +The gutter hangers are incorrectly installed.-Attention.

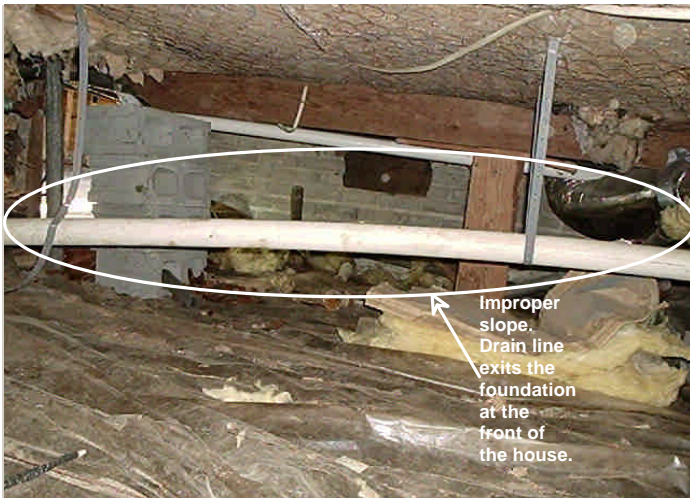
+ Given the age of this residence, it is possible that the drainpipes are old. Older piping is susceptible to decay, therefore, it would be prudent to ask the sellers if they have replaced the piping, ever had blockages in the main drainpipe, and/or have the line video-scanned - Review.
+There is visible corrosion on the drain/vent piping.-apartment-Attention
+The drain lines did not slope for proper drainage.-kitchen sink drain-Attention.
